PERIODIC STRUCTURAL STABILITY ASSESSMENT REPORT

**ASH BASIN NO. 1
MONTOUR STEAM ELECTRIC STATION
DERRY TOWNSHIP, MONTOUR COUNTY, PENNSYLVANIA**

**MONTOUR, LLC
WASHINGTONVILLE, PENNSYLVANIA**

November 2020

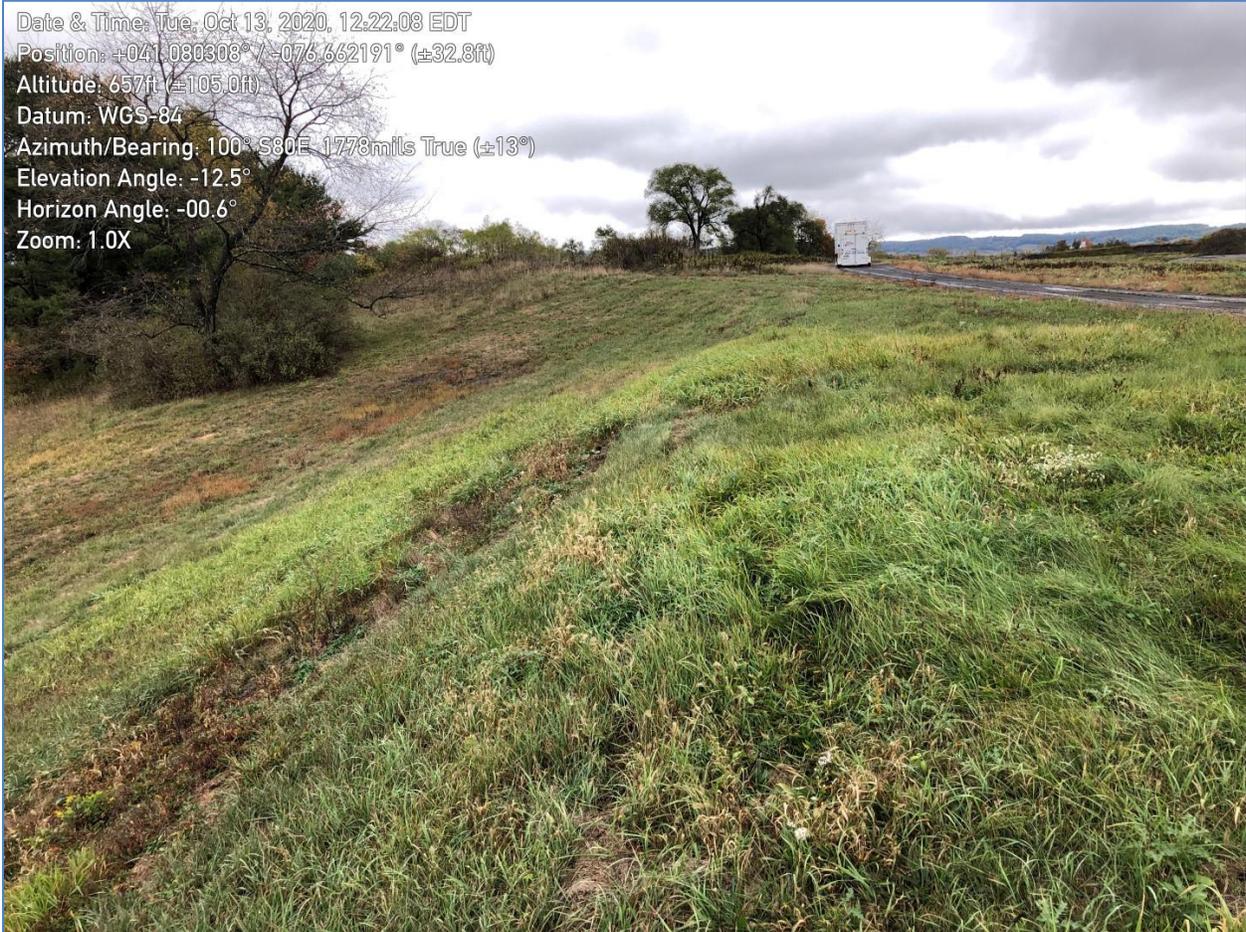
According to Section 3.5 of the Basin 1 History of Construction Report, the Basin 1 perimeter dike was primarily founded on bedrock consisting of weathered shale. The perimeter dike ties into natural existing grade at the northeastern and southeastern corners of the basin. According to the History of Construction Report, the abutment material at these locations consists of residual soils overlying weathered shale. A view of these northeastern and southeastern dike corners are shown in Photographs 1 and 2 in Appendix B.

Photograph 1 – Northern Abutment (looking south)

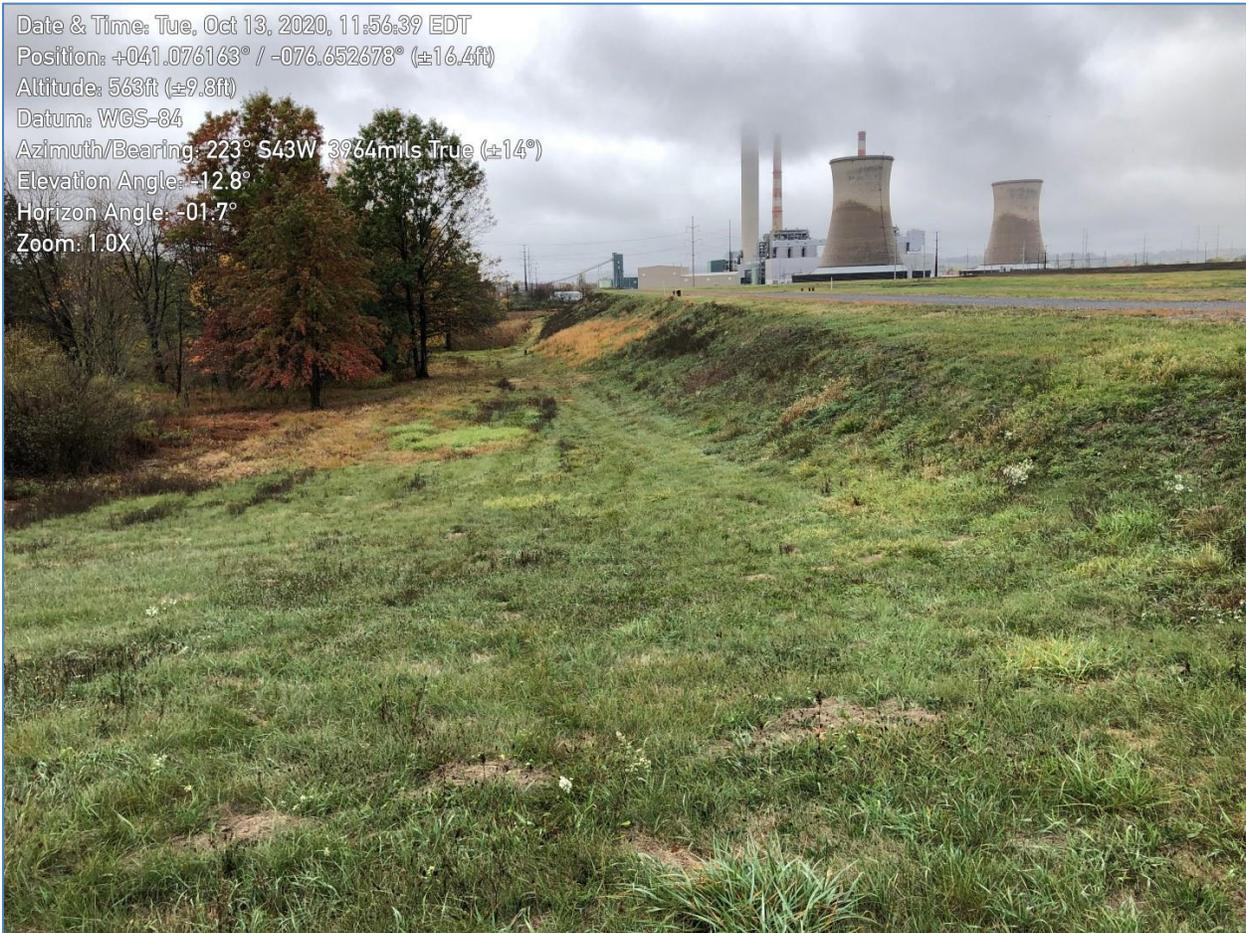
Photograph 2 – Southern Abutment (looking west)

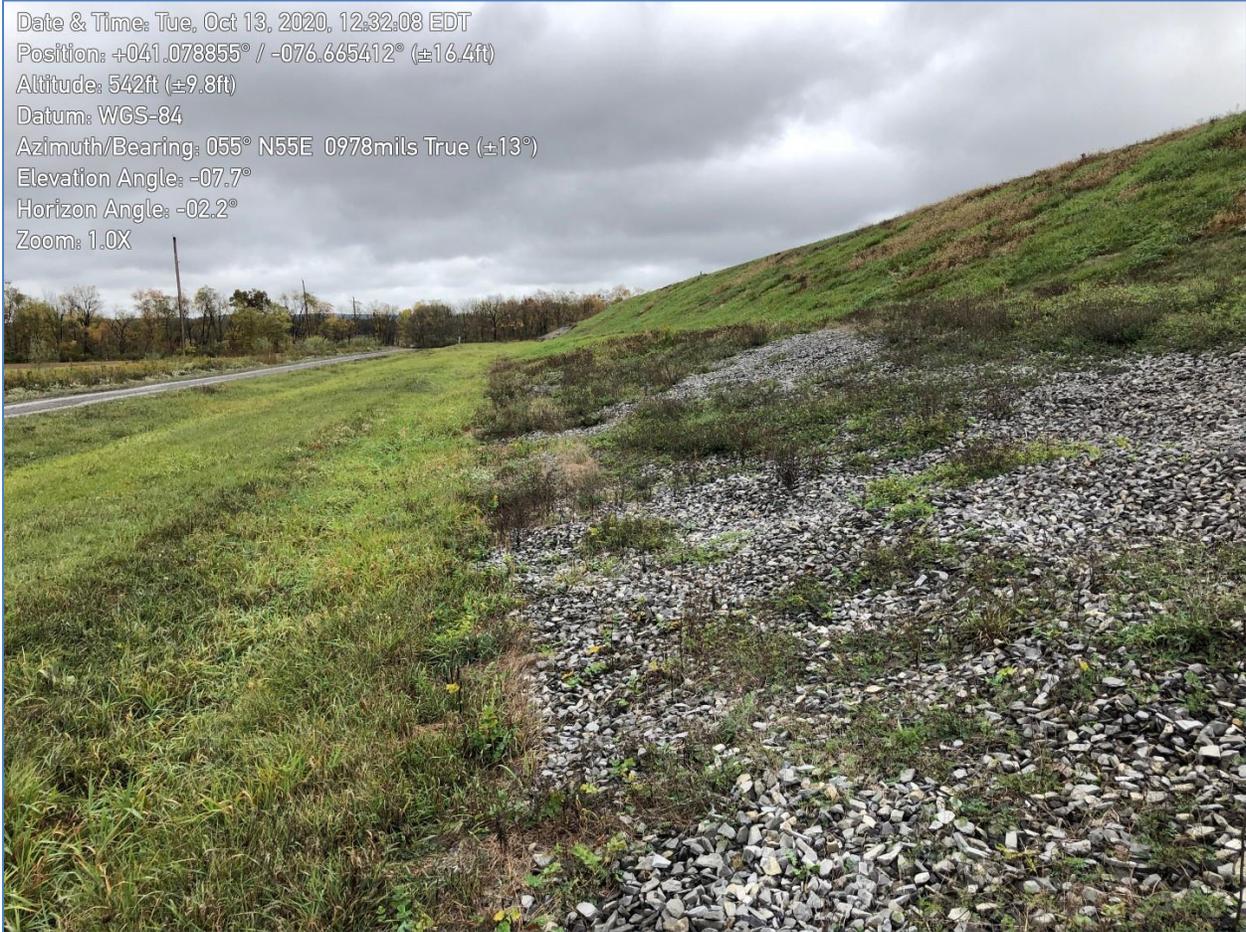
The seep that was observed during CEC's site visit in June 2016 at the toe of the northern dike slope, just upstream of the seepage collection system was not observed during our site visit in October 2020. According to our conversations with Talen, this seep occurred due to a blockage in the seepage collection system which was cleaned out in October 2016. A view of this area from our October 2020 site visit can be seen in Photograph 3 in Appendix B.

Photograph 3 – Previously observed seep at toe of northern dike slope and now dry (looking east)

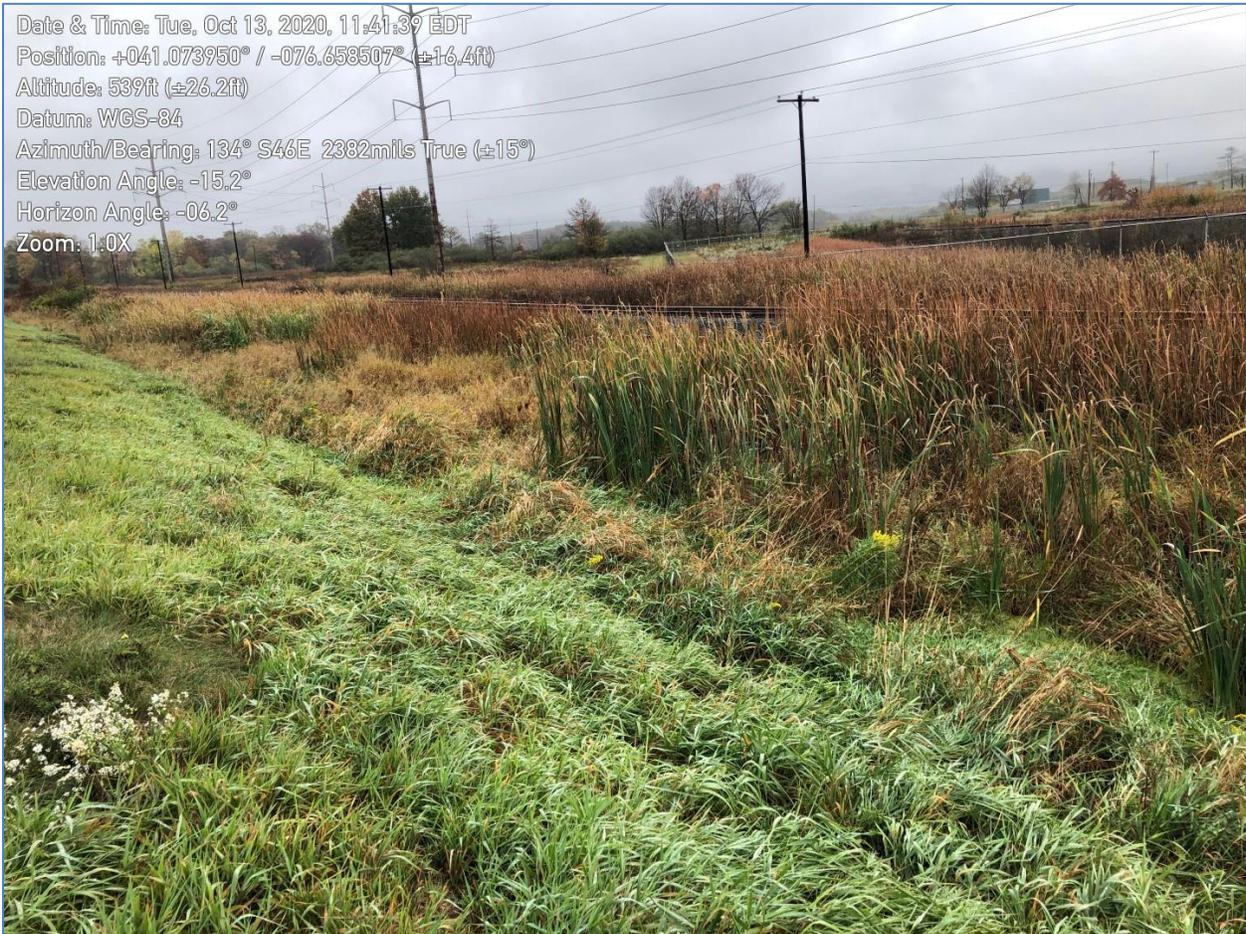
Evidence of ponding water in the form of vegetation typically associated with wetlands was observed between the existing rail line and the toe of the southwestern dike slope, east of the pipe bridge, at the time of our site visit as shown in Photograph 4 in Appendix B. No evidence of ponding water was observed between the toe of slope and rail line to the west of the pipe bridge. No signs of slope instability were observed along the southwestern dike slope. A rock buttress was constructed in 2007 along the southwestern downstream dike slope in the area of the pipe bridge to increase stability.

Photograph 4 – Evidence of ponding water at toe of southern dike slope

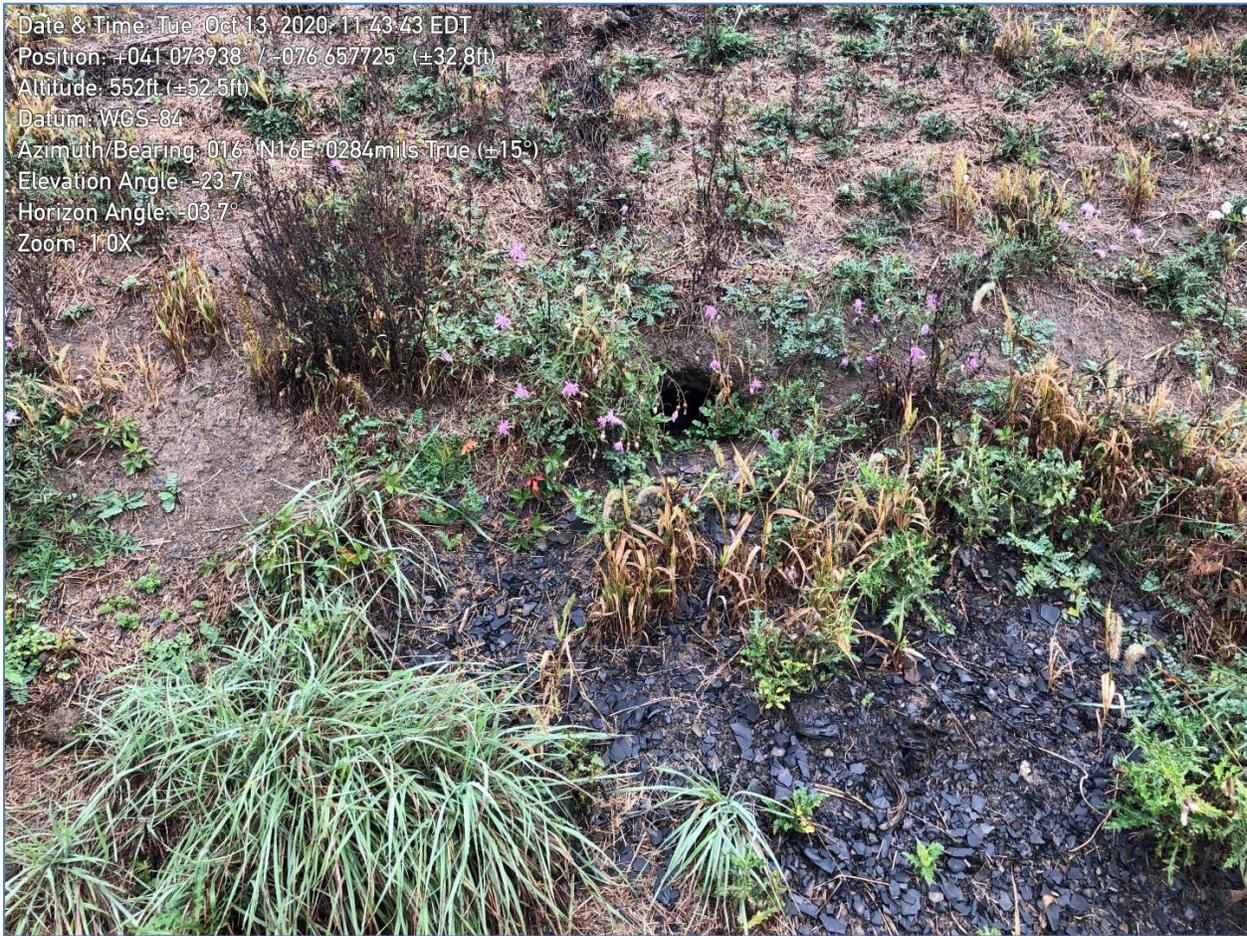
At the time of CEC's site visit, downstream dike slopes were mostly covered with grassy vegetation excluding the areas where riprap has been placed and where the overtopping protection was installed. CEC observed ten animal burrow holes, each approximately 6 to 12 inches in diameter along the downstream dike slopes. These holes were present near the northeastern basin corner and southern basin dike. One of these holes is shown in Photograph 5 in Appendix B. Based on our observations and conversations with Talen, animal holes are filled on a regular basis as part of their normal maintenance and the holes observed by CEC will be filled in accordance with their Operations Manual for Basin 1. The downstream dike slopes

Photograph 5 – View of animal burrow hole on southern downstream dike slope

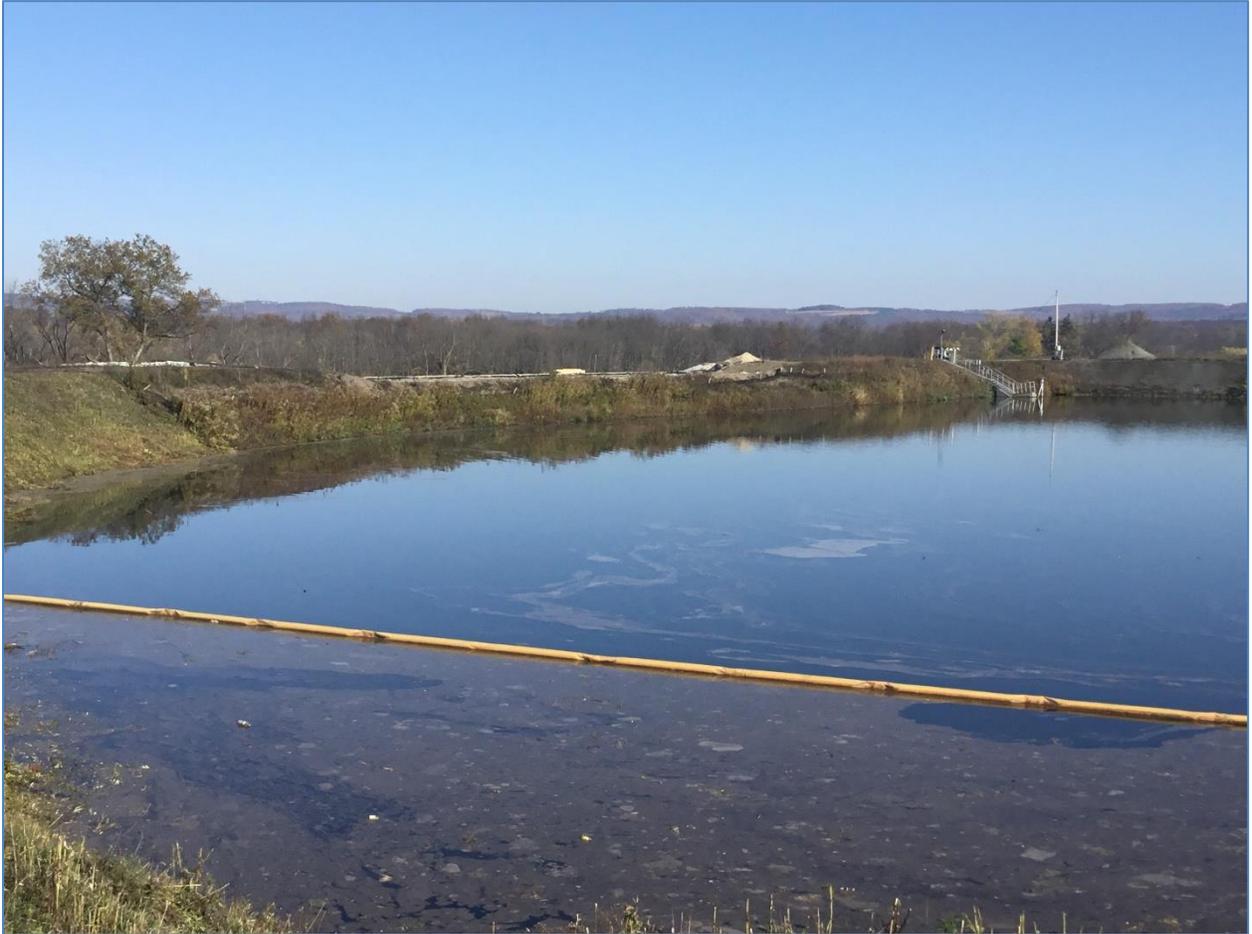
The vegetation on the upstream slopes of Subbasin C was generally taller than the maximum 6-inch requirement and some woody vegetation was present. Talen mowed this vegetation subsequent to our visit and provided photographs after mowing as shown in Photographs 6 and 7. Mowing could not be performed along the upstream slope of Subbasin C in the area where the overtopping protection was installed. Talen informed CEC that this area will be mowed along with seeding of areas disturbed during overtopping protection installation as part of site restoration. A photo of the upstream slope in Subbasin B is shown in Photograph 8 in Appendix B.

Photograph 6 – Northern upstream slope of Subbasin C

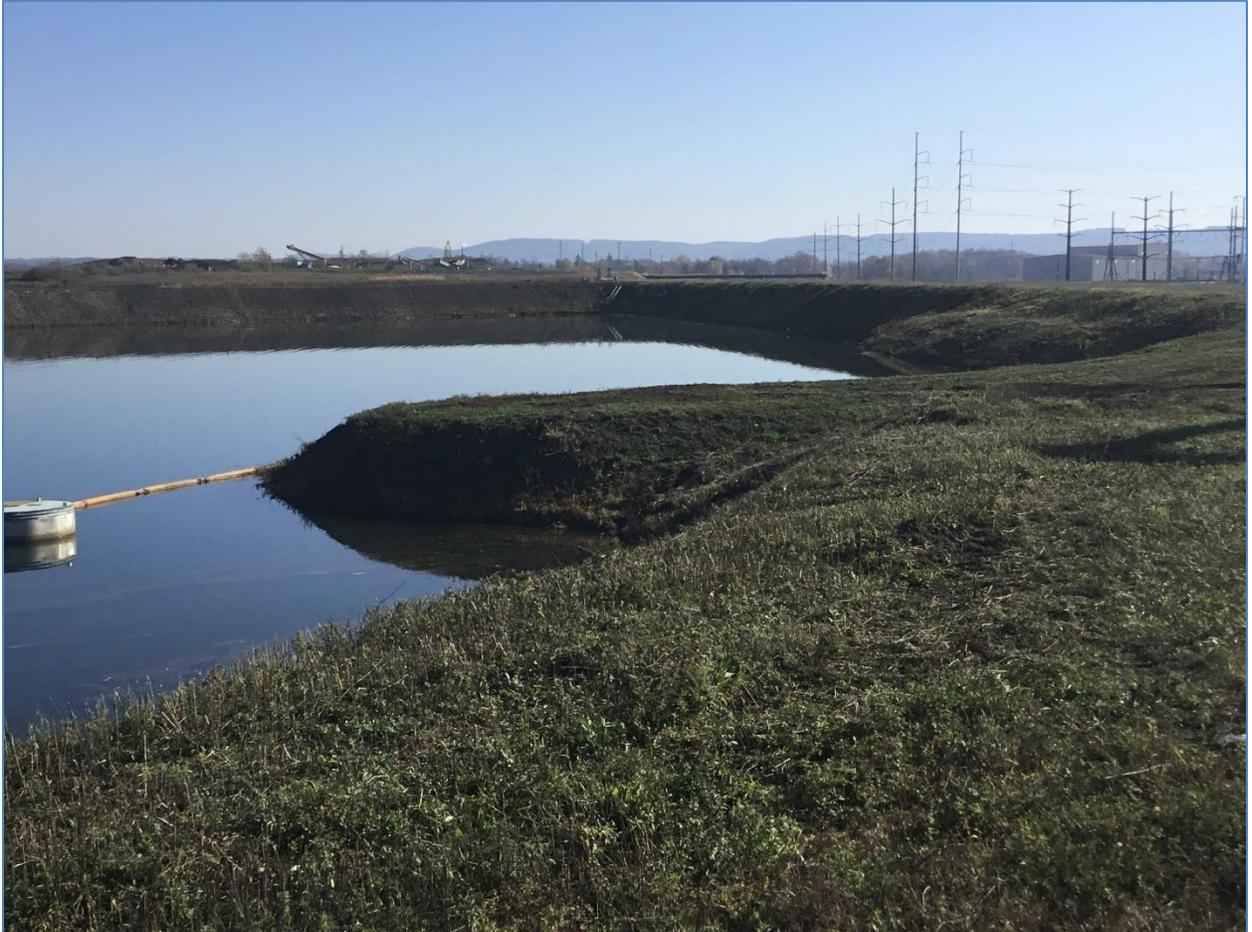
Photograph 7 – Western and southern upstream slopes of Subbasin C

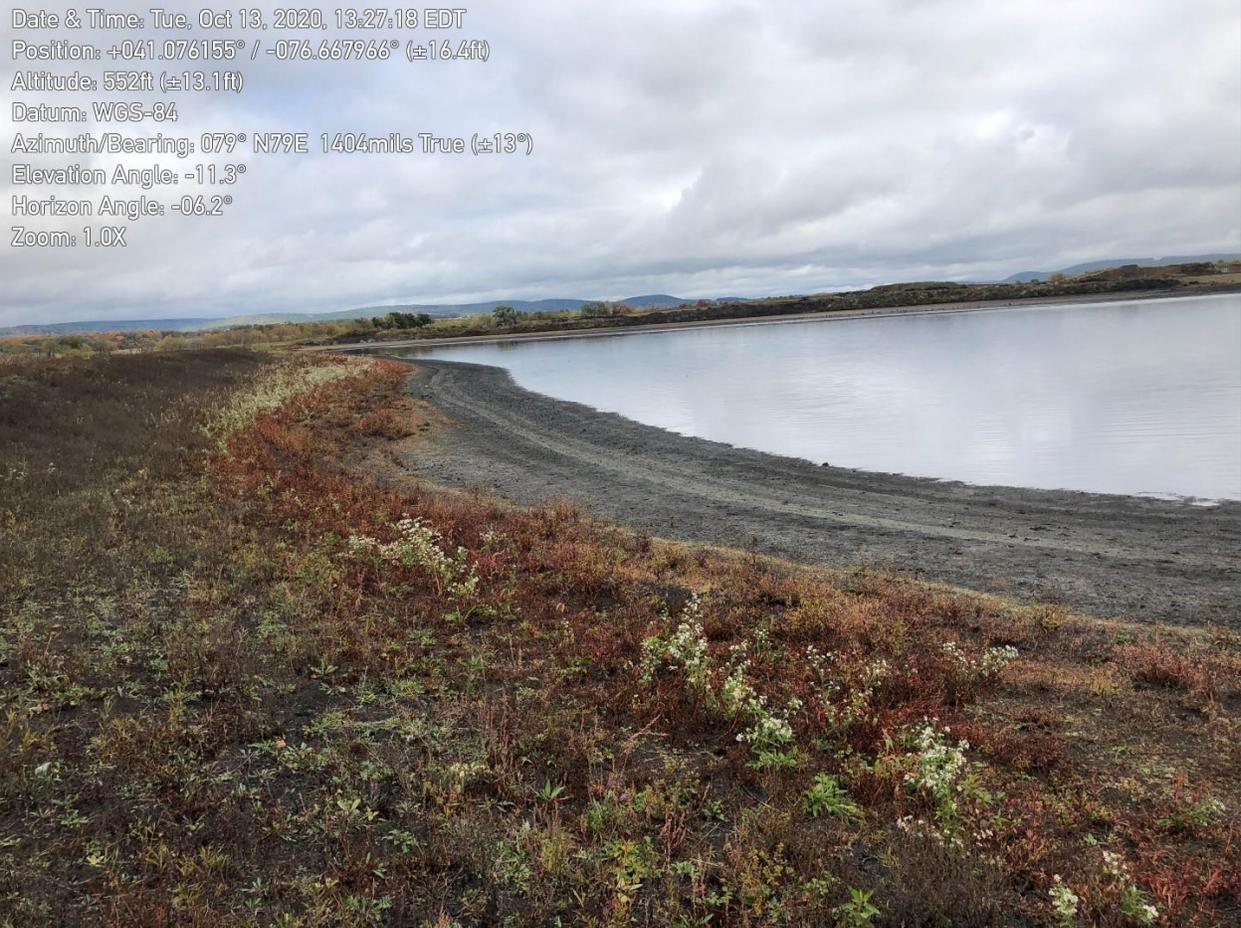
Photograph 8 – Northwestern upstream slope of Subbasin B (looking northeast)

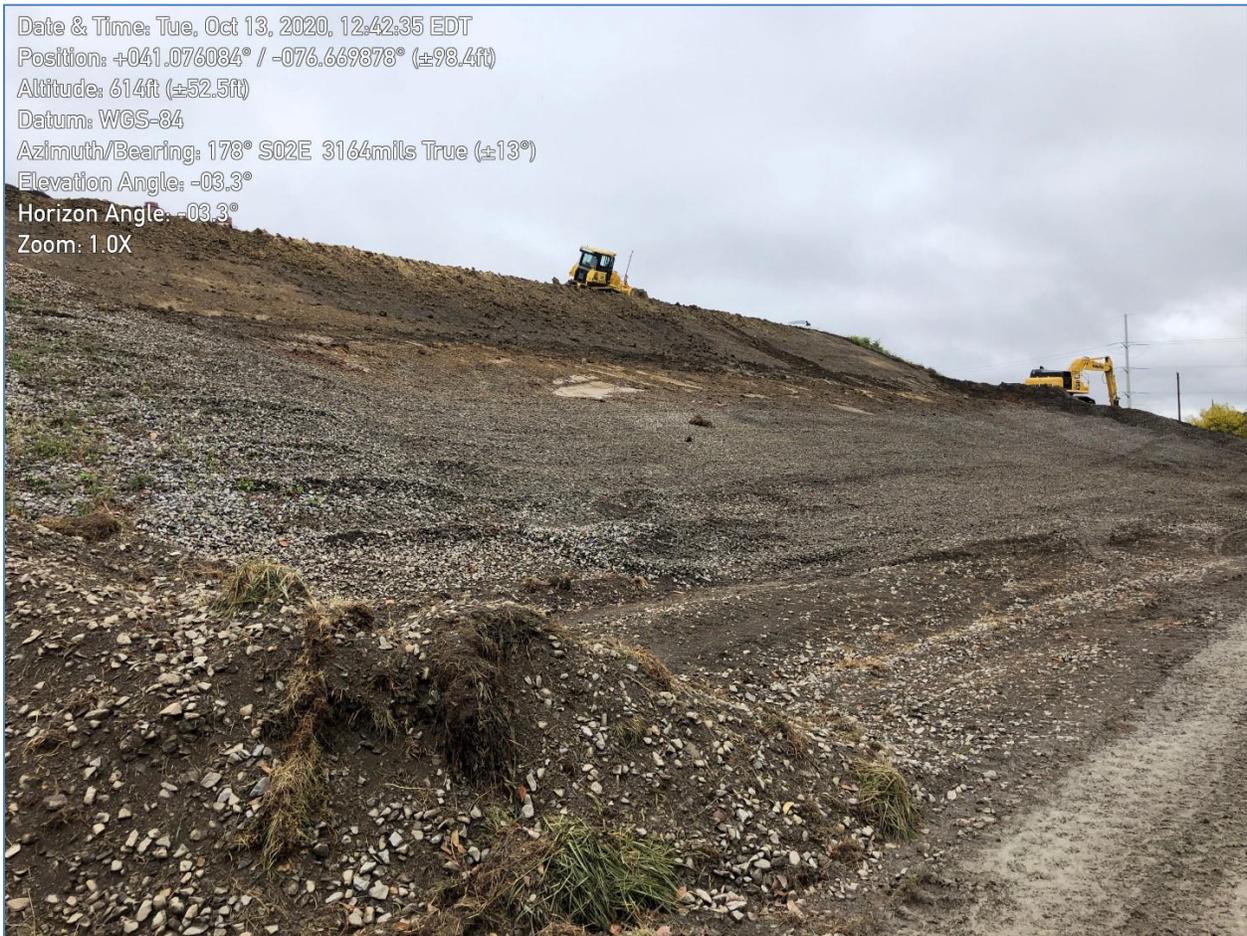
Montour has installed overtopping protection on the northwestern portion of the Subbasin C dike that consists of lowering and armoring with articulating concrete block a section of the dike approximately 150-foot wide to Elevation 562 which was approved by the Pennsylvania Department of Environmental Protection (PADEP) Chapter 105 Regulations and as a Minor Modification to the Solid Waste Permit No. 301315 and by the PADEP's Dam Safety Department. The installation of this overflow section increases the discharge capacity to manage the CCR Rule design storm. This design is presented in the Periodic Inflow Design Flood Control System Plan by Gannett Fleming, Inc dated November 2020. Photograph 9 shows the construction of the overtopping protection during our site visit. The construction was substantially complete and able to safely pass the design storm on November 17, 2020.

**Photograph 9 – Construction of overtopping protection on downstream slope
in Subbasin C (looking west)**

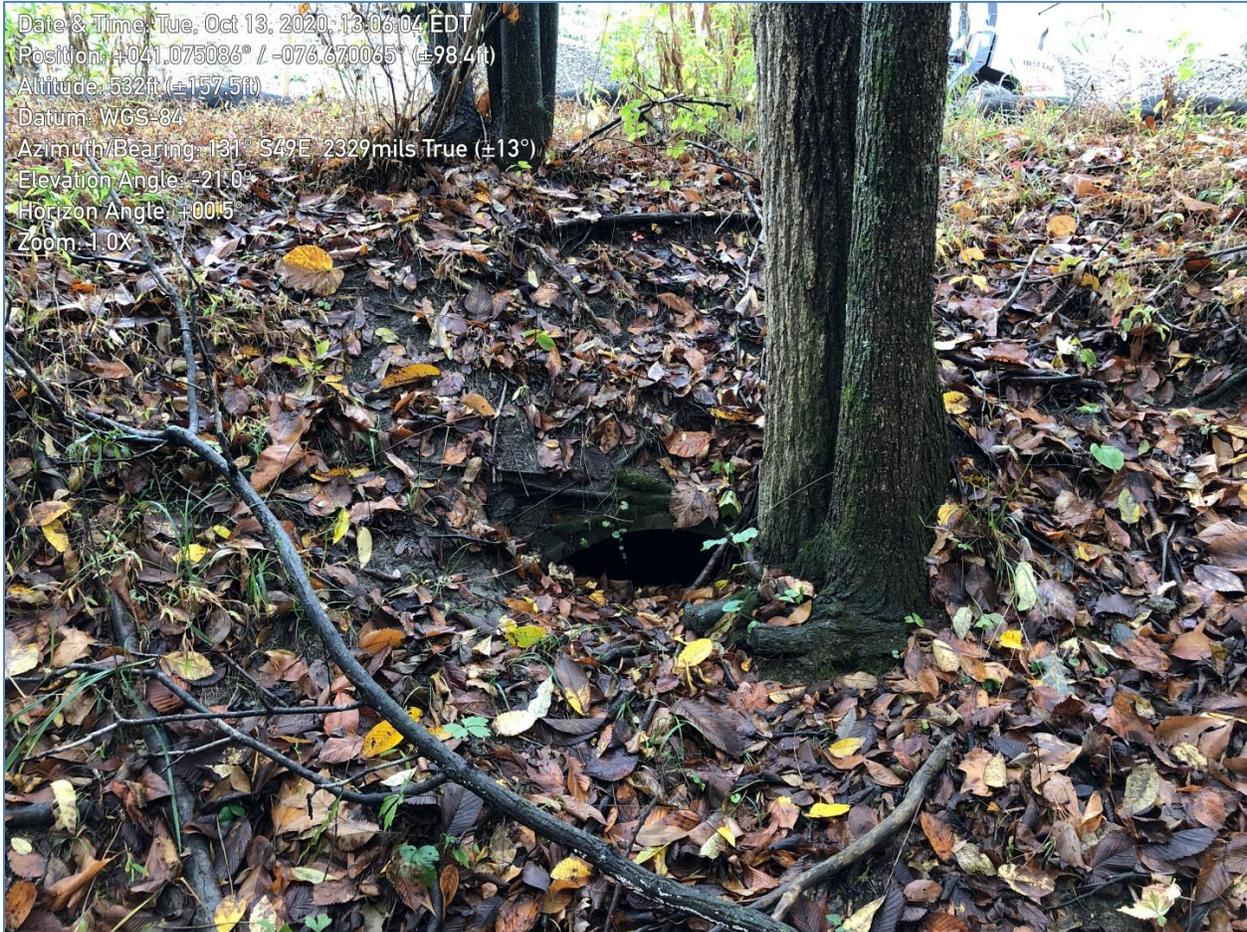
Two abandoned reinforced concrete pipe culverts are present beneath the dike on the north side of Basin 1 as shown on Figure 2. The outlet of the western plugged culvert is exposed and is shown in Photograph 10 in Appendix B. According to the Initial Annual Inspection Report, this pipe was inspected from the downstream end with a ROV by Talen in 2014. A concrete plug was encountered during the inspection approximately 59 feet from the outlet end. Drawing G-199945-13 by Ebasco Services, Inc. dated March 15, 1968 indicates that the eastern plugged culvert was temporarily installed to allow flow of an existing creek through the dike embankment, most likely during construction. The exact location of the eastern plugged culvert is unknown.

Photograph 10 –Abandoned overflow culvert pipe outlet (plugged)

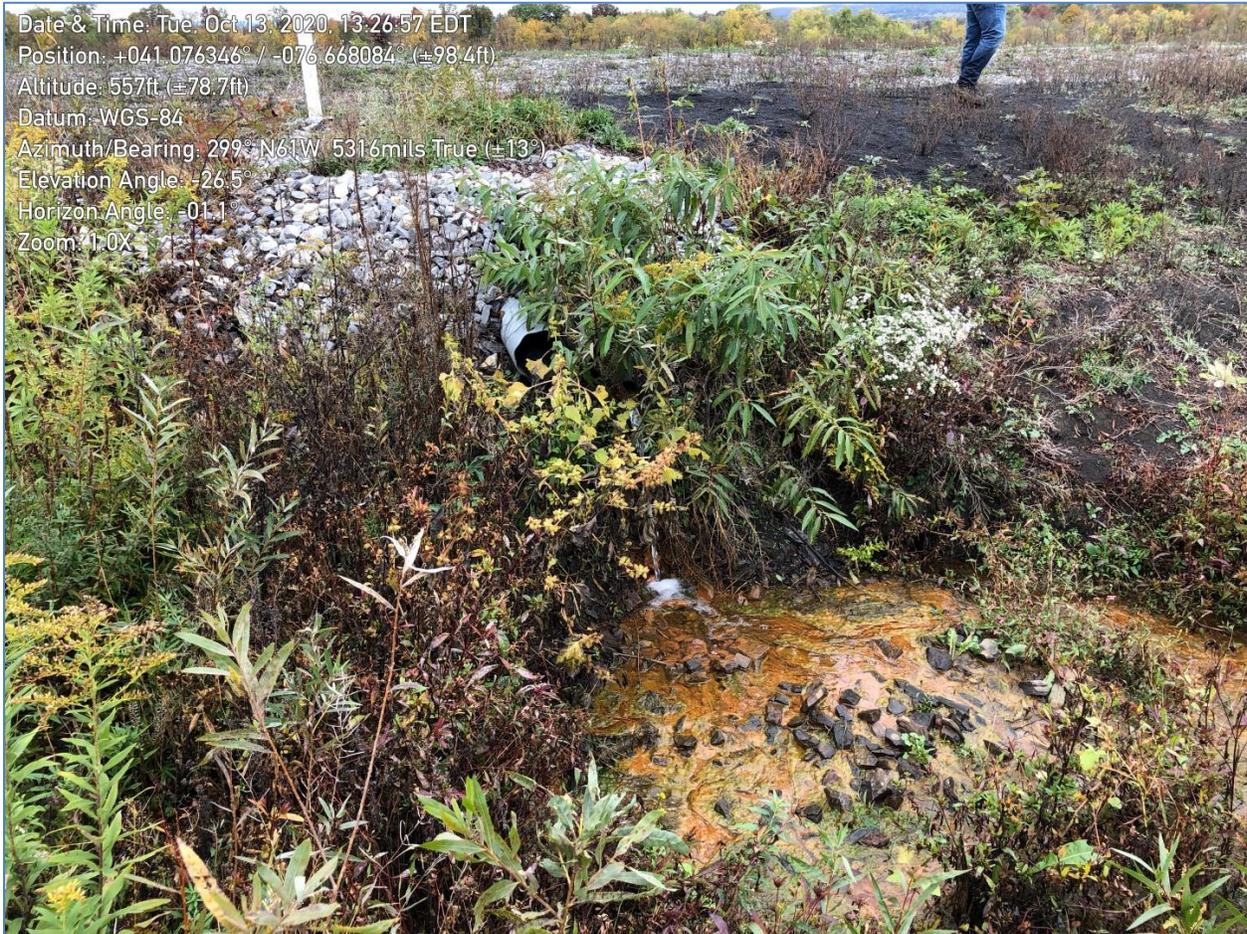
In 1973, a seepage collection system was installed on the northwestern side of the basin for collecting seepage water and conveying it back to Basin 1. In 1979, the system was extended farther to the northeast and an additional pump station was added to convey the seepage water back to the basin. The collection system consists of a buried interceptor trench at the downstream toe of the northern dike. The trench contains a pipe that is sloped to convey water to four manholes positioned along its length. The manholes are equipped with submersible pumps that operate via level controls to pump the accumulated water back into the basin. Pipes pass through the northern dike to convey pumped water from the seepage collection system to Subbasin B. Some of the pipes were observed to be flowing during our site visit and based on our observations and conversations with Talen, are buried at a relatively shallow depth, just below the crest. One of these pipes is shown in Photograph 11 in Appendix B.

Photograph 11 – Seepage collection system outlet pipe located within Subbasin B

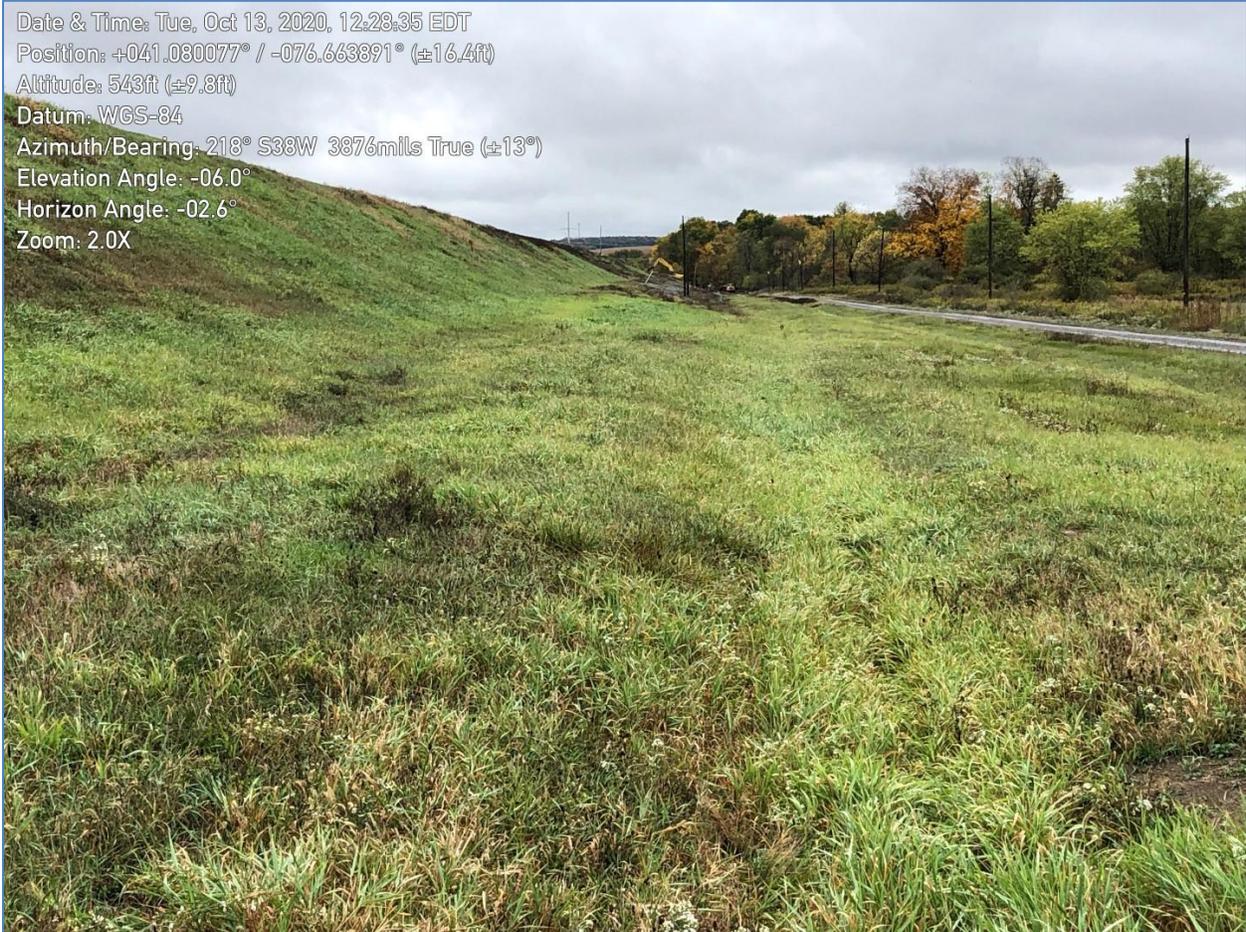
Photograph 12 – Northern downstream slope (looking west)

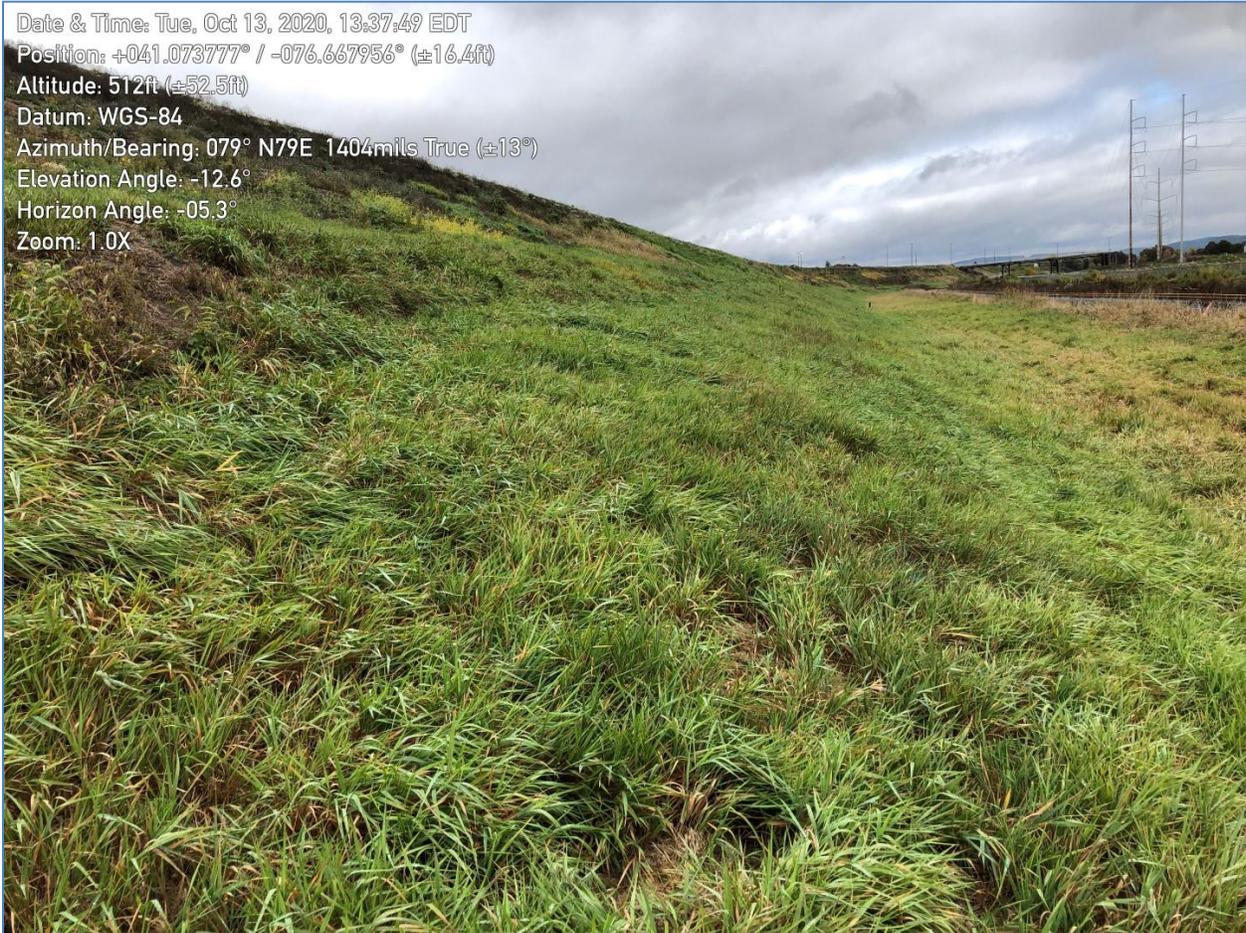
Photograph 13 – Southern downstream slope and dike crest (looking west)

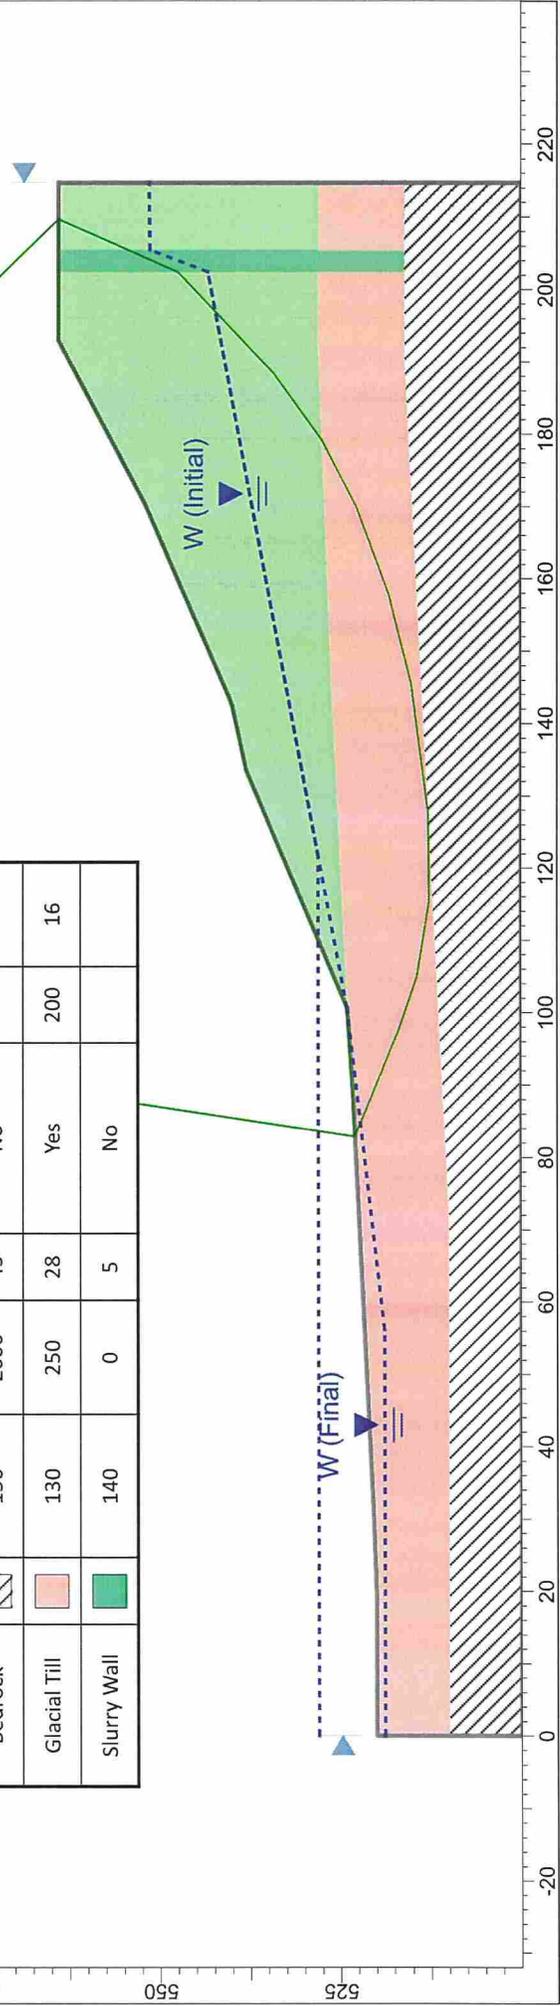
Montour SES Basin 1
 Initial Safety Factor Assessment
 Cross Section 1-1 -- Downstream Rapid Drawdown

Section 257.73(e) of the CCR Rule does not specify a minimum FS for rapid drawdown. However, the regulations suggest that this evaluation be completed, if applicable. The US Army Corps of Engineers (USACE) Engineering Manual EM 1110-2-1902 "Slope Stability" (October 2003) recommends a minimum FS of 1.1 (drawdown from maximum surcharge pool) and 1.3 (drawdown from maximum storage pool). The maximum water level used in the analysis is an extreme event (dam breach under the probable maximum precipitation event) so the lower FS is recommended. Based on our analysis, a FS of 1.4 was calculated for this drawdown scenario. Refer to the Basin 1 Initial Safety Factor Assessment Report for more information regarding the subsurface conditions and analysis methodology.

1.4
