**Subject: 2022 USEPA CCR Surface Impoundment Annual Inspection Report
Montour Steam Electric Station Ash Basin No. 1**

APPENDIX A
INSPECTION PHOTOGRAPHS

SITE PHOTOGRAPHS
MONTOUR ASH BASIN 1
ANNUAL INSPECTION

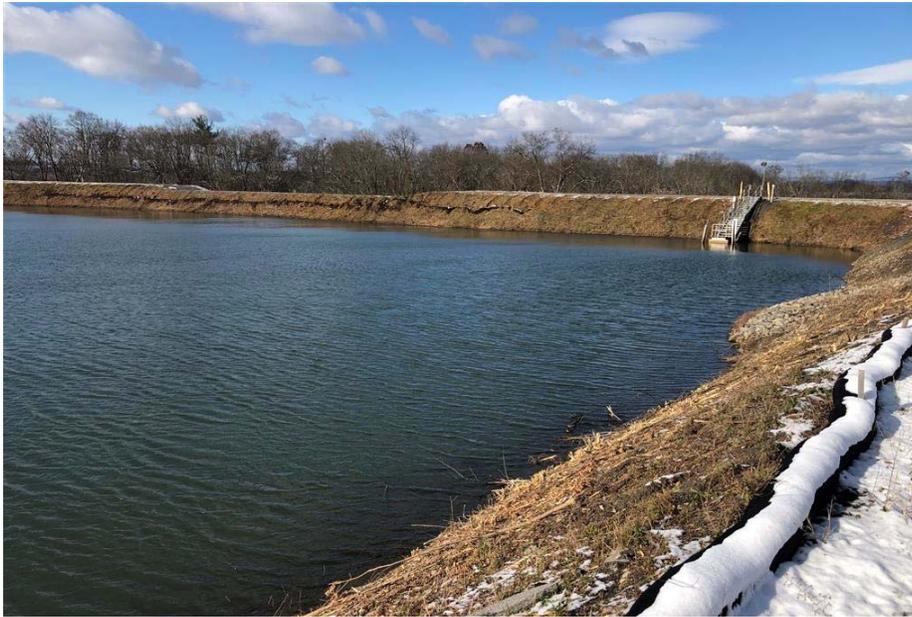
The vegetation on the upstream slope of Sub-basin C had been recently trimmed and the above-water part of the slope was visible. As noted in previous inspection reports, the upstream slope of Sub-basin C had been filled to widen the crest road for truck access, resulting in steep upstream slopes. Slope stability analyses have verified that the embankment is sufficiently wide to provide an adequate factor of safety for critical failure surfaces.

Picture 1- Inside slope of Cell C

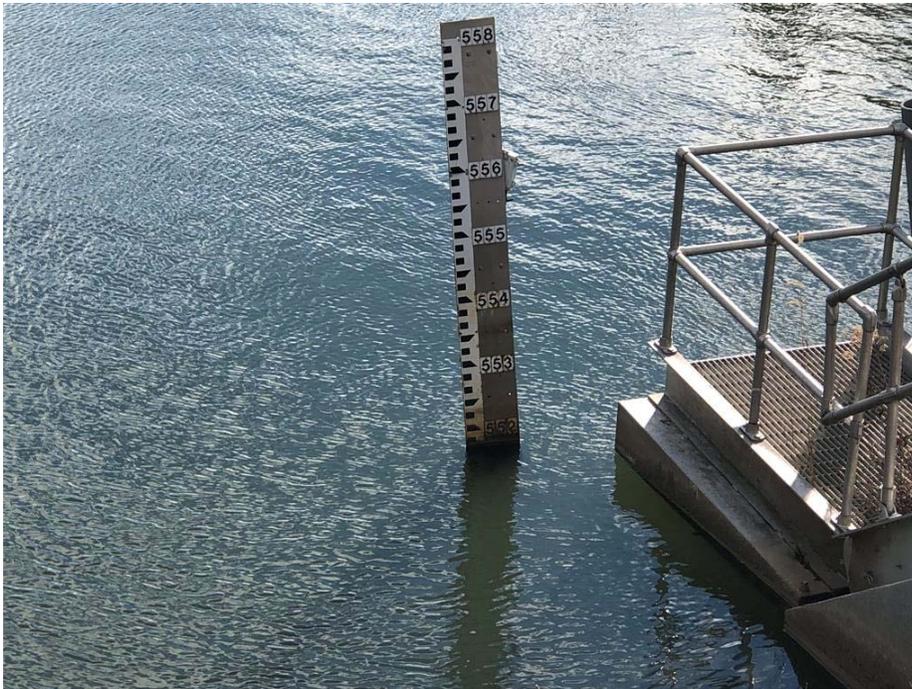
Picture 2 - Staff Gauge in Cell C

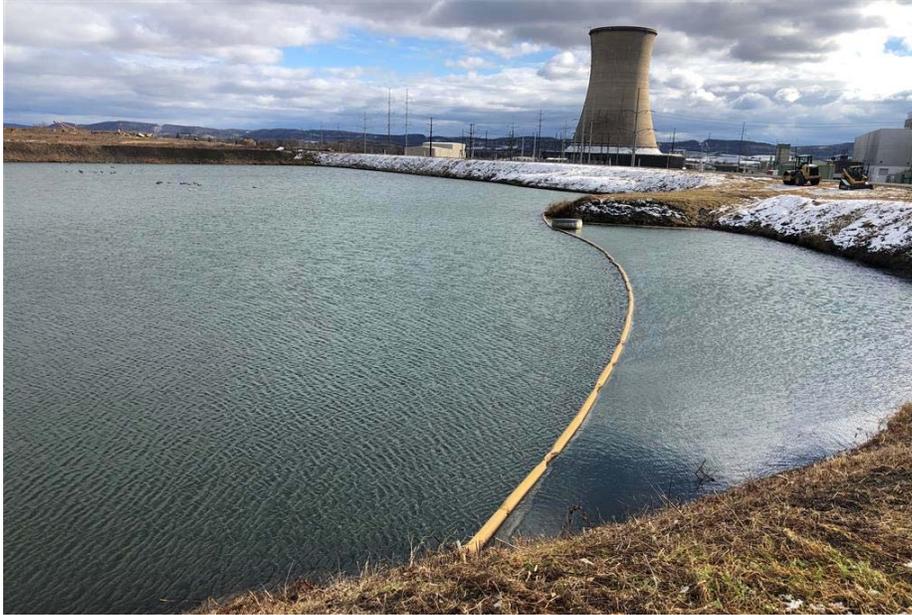
Picture 3- Discharge structure draining Cell C to the detention basin.

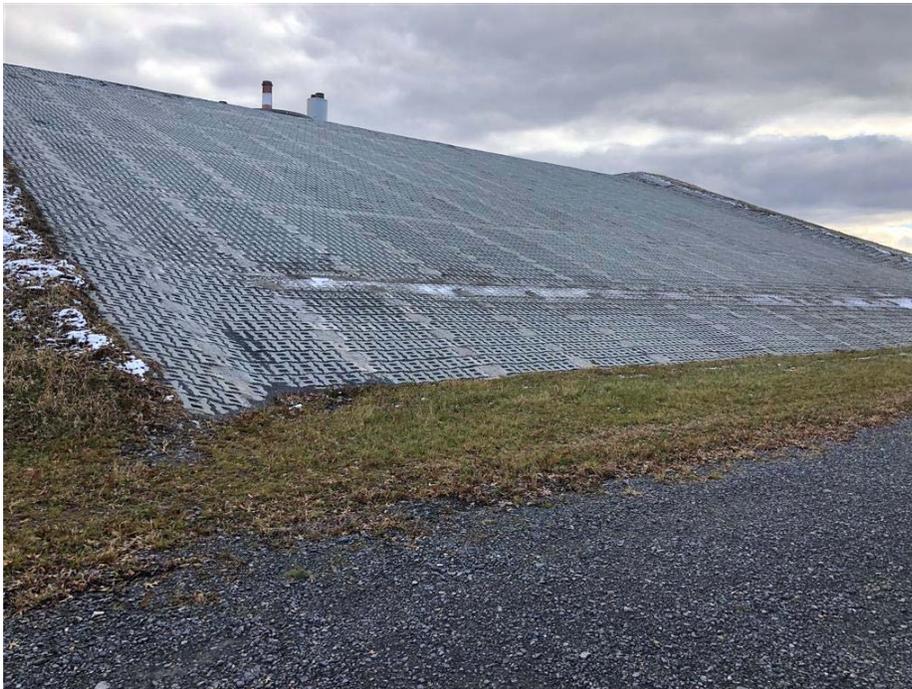
Picture 4 – Overtopping section in cell C.

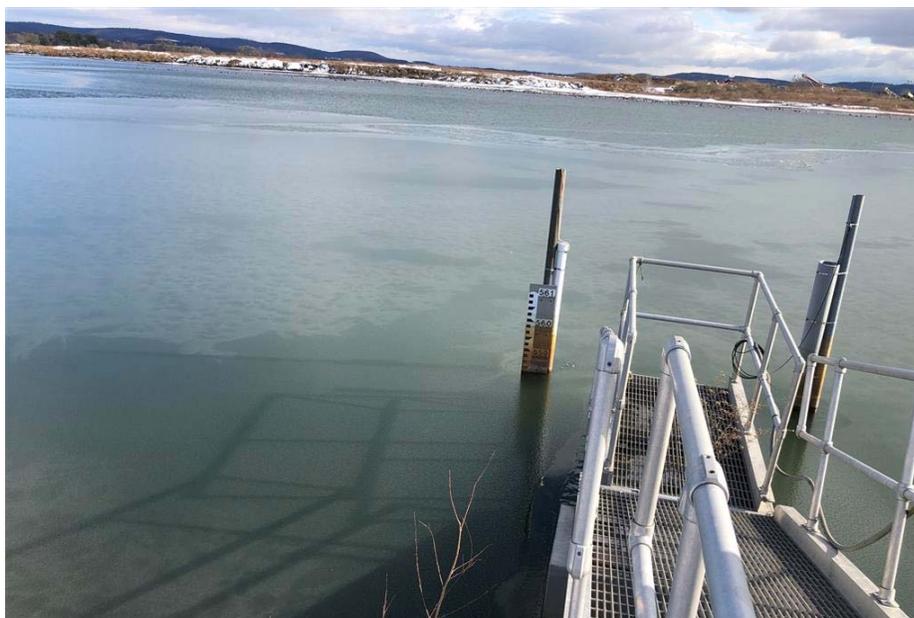
Picture 5 - Staff gauge in Cell B.

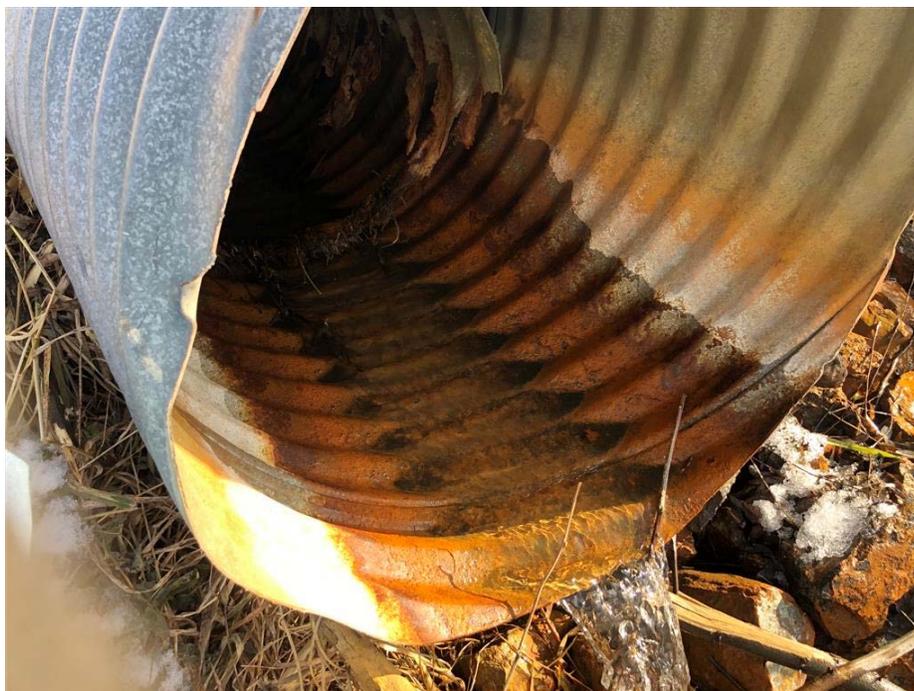
The two 18" CMP discharge conduits through the internal splitter dike from Cell B to Cell C showed signs of corrosion at the end of the pipe where the pipes pass through the dike and are exposed on all sides of the pipes. Talen has installed sacrificial CMP pipes over these portions of the discharge conduits for protection.

Picture 6 – Discharge pipe (1 of 2) from Cell B to Cell C.

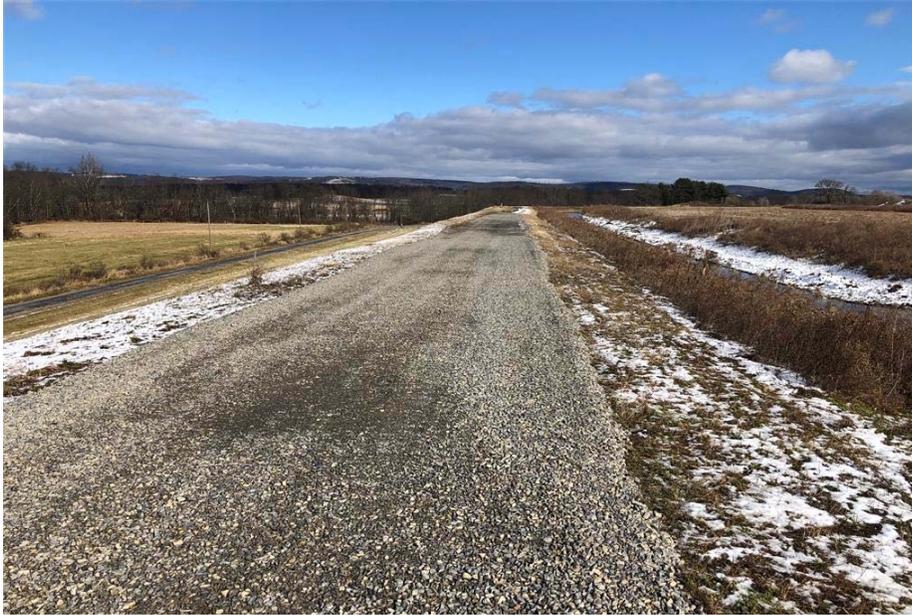
The crest road is surfaced with gravel and was in good condition. With the basin still in active service, the road is used regularly. Talen surveyed the crest road and raised the low areas of the crest with road base material and raised the crest of the splitter dike between Sub-basins B and C up to 1.5 feet to match the design elevations in 2014. The crest road was surveyed in 2021 and few areas that were slightly below the design elevation were raised to the design elevation prior to the inspection. There was no visible evidence of settlement, movement, or instability extending to the crest. The eastern access road is paved in sections with cracking and potholing evident, but this section of the basin does not normally retain water.

Picture 7 - Crest road and embankment.

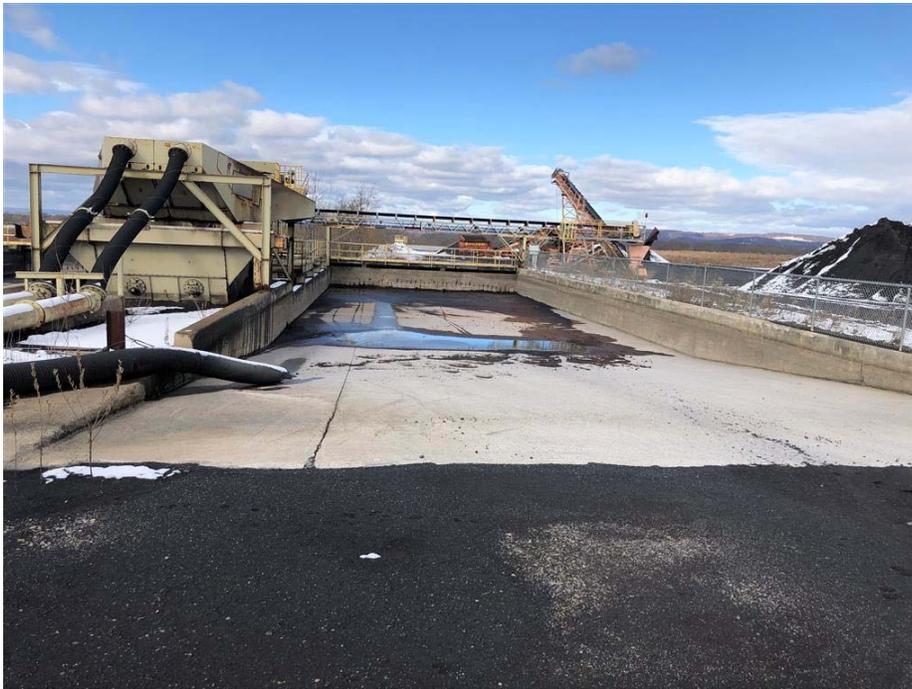
Picture 8 – Bottom ash and mill rejects dewatering system.

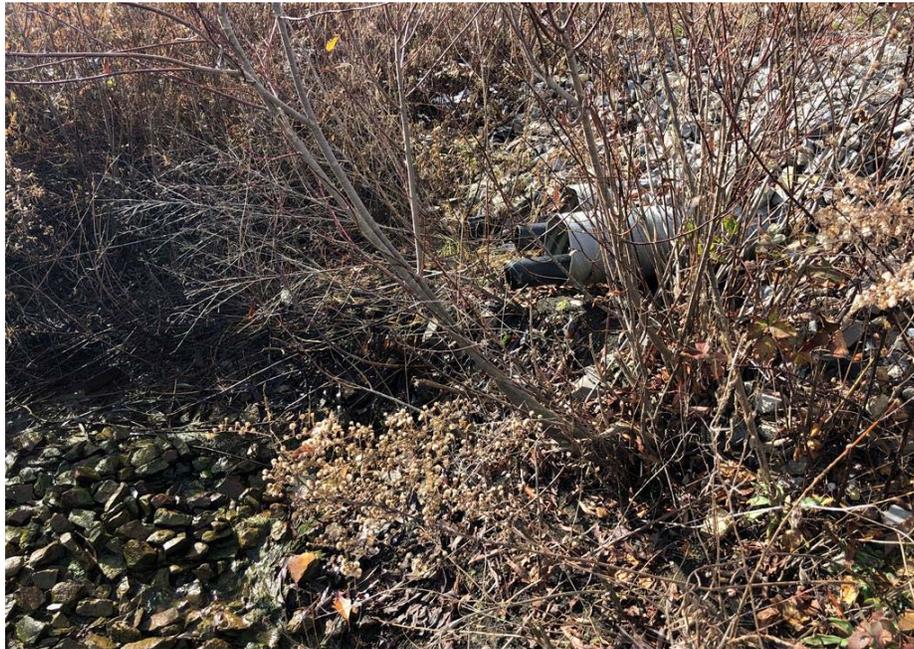
Picture 9 - Dewatering Well #1 discharge into Cell B.

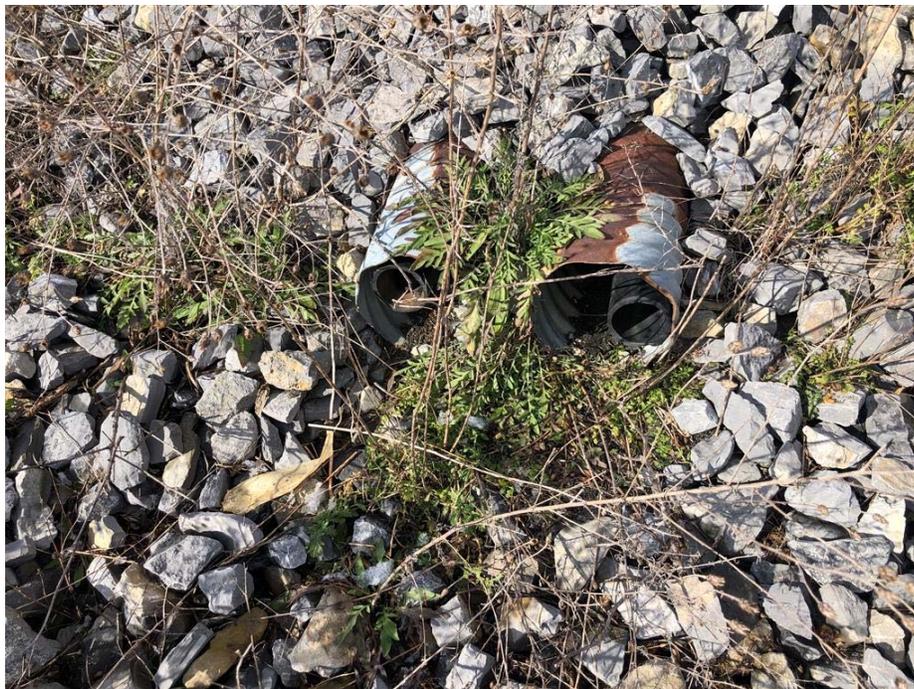
Picture 10 – Dewatering Well #2 discharge into Cell B.

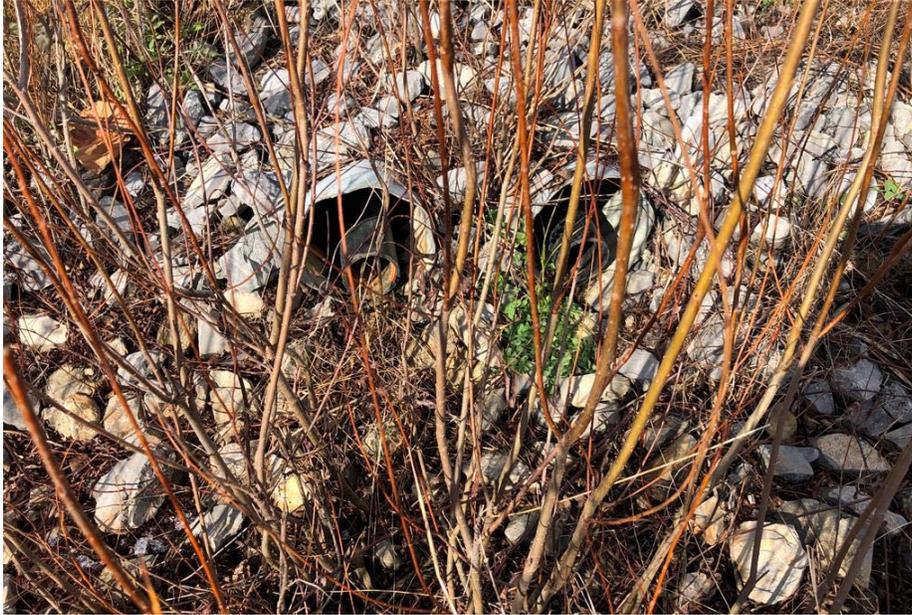
Picture 11 - Dewatering Well #3 discharge into Cell B.

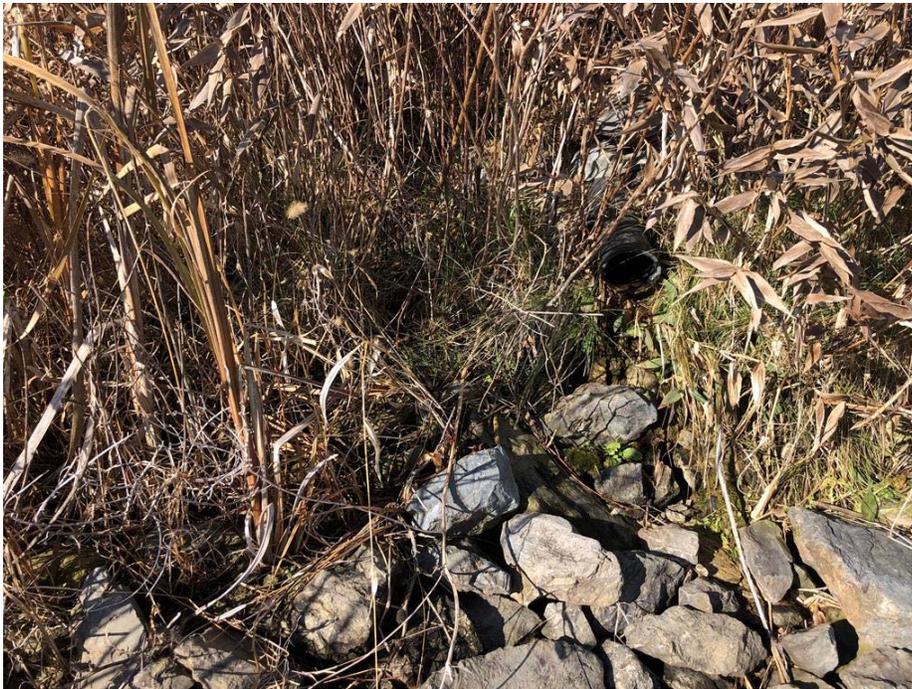
Picture 12 - Dewatering Well #4 discharge into Cell B.

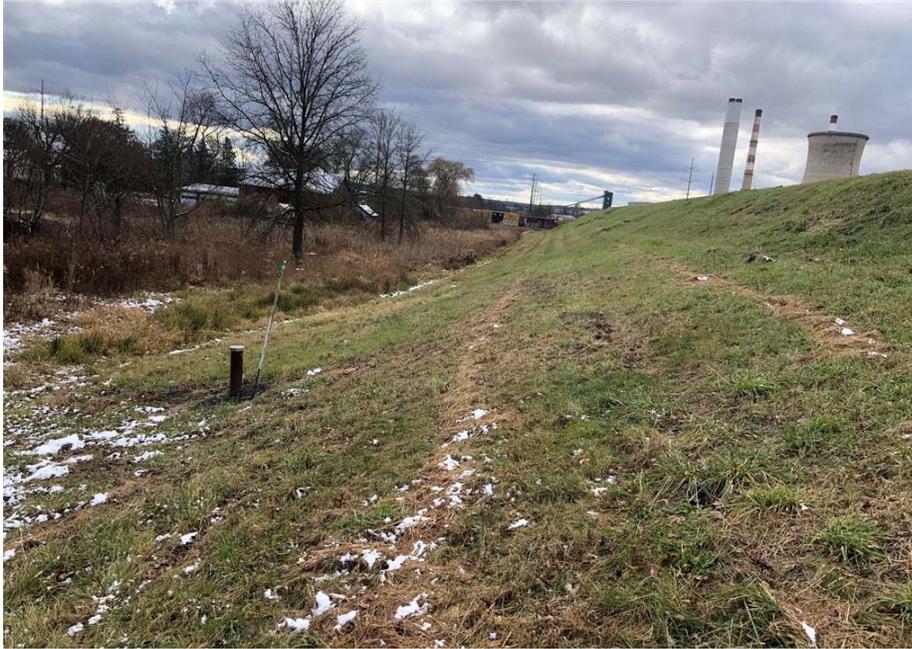
Picture 13 - Downstream face embankment. Groundhog holes were observed and no other signs of distress were observed.

6 animal burrows, presumed to be woodchucks, were observed in the downstream slope. Talen has been trapping for the last seven years and noted that they annually fill the groundhog holes. The holes will be filled by inserting a grout hose as far as it will go into the hole and pumping the hole with flowable fill until return is observed. Eradication and hole-filling efforts should be continued.

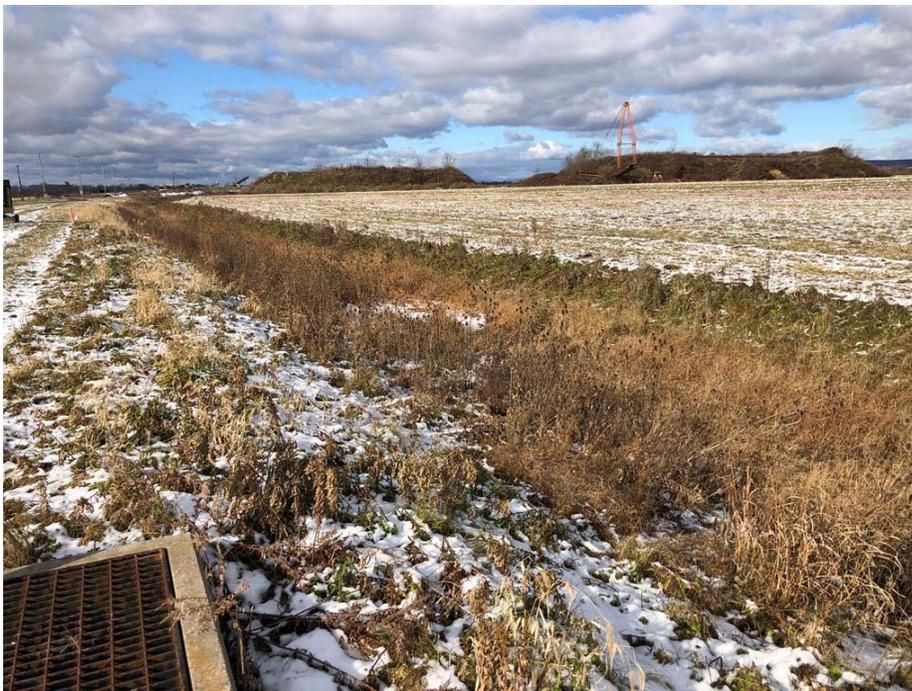
Picture 14 – The majority of the upstream face in cell A has an interior swale discharging stormwater runoff into cell B.

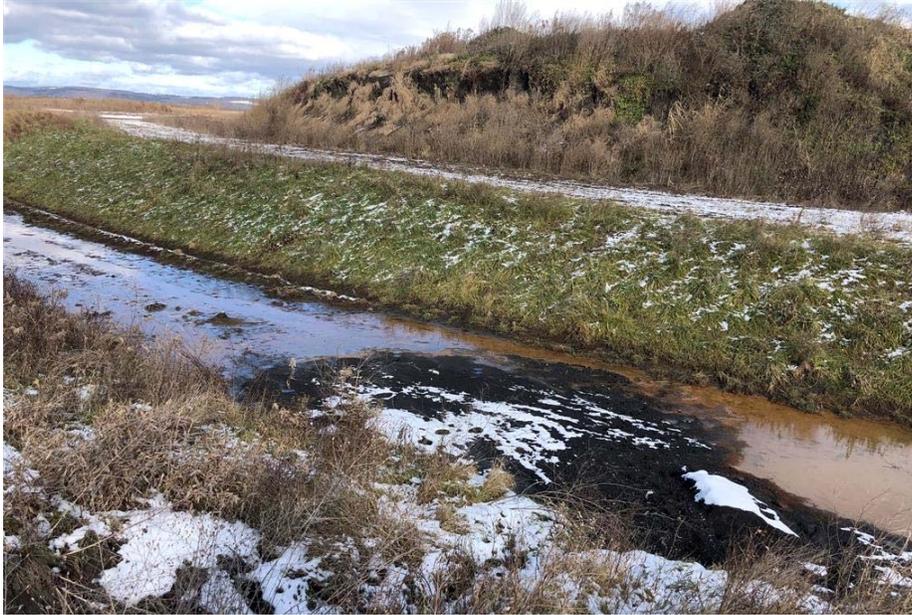
Picture 15 - Erosion in internal swale in cell A.

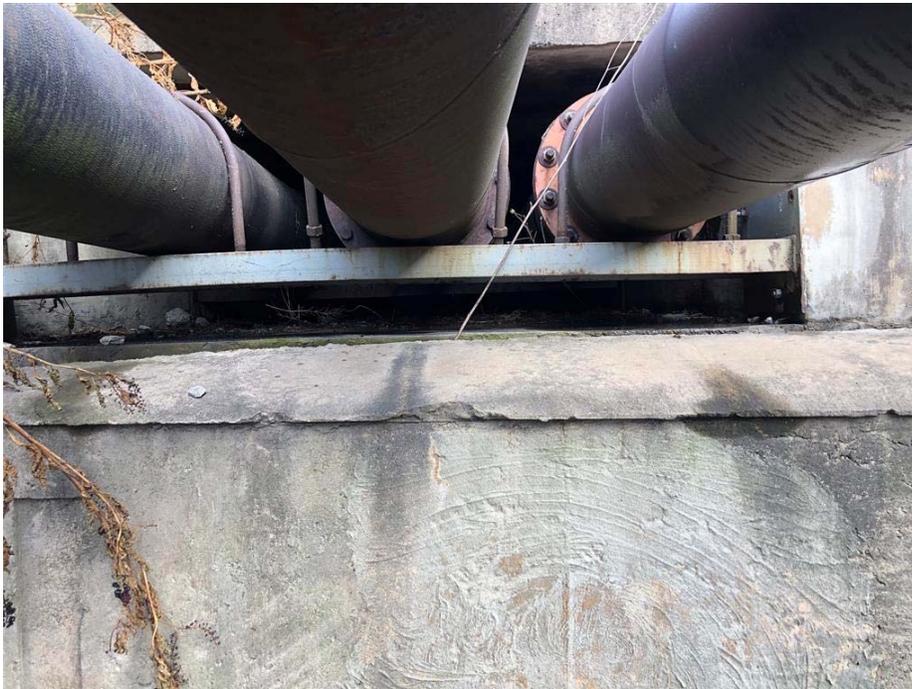
The undermined footing for the pipe bridge noted in previous reports was repaired in 2010. Cold joints, small voids, and unconsolidated concrete were evident, but the concrete filled the majority of the void. The footing should continue to be monitored for potential undermining.

Picture 16 – Concrete pipe bridge abutment where the pipes enter the basin.

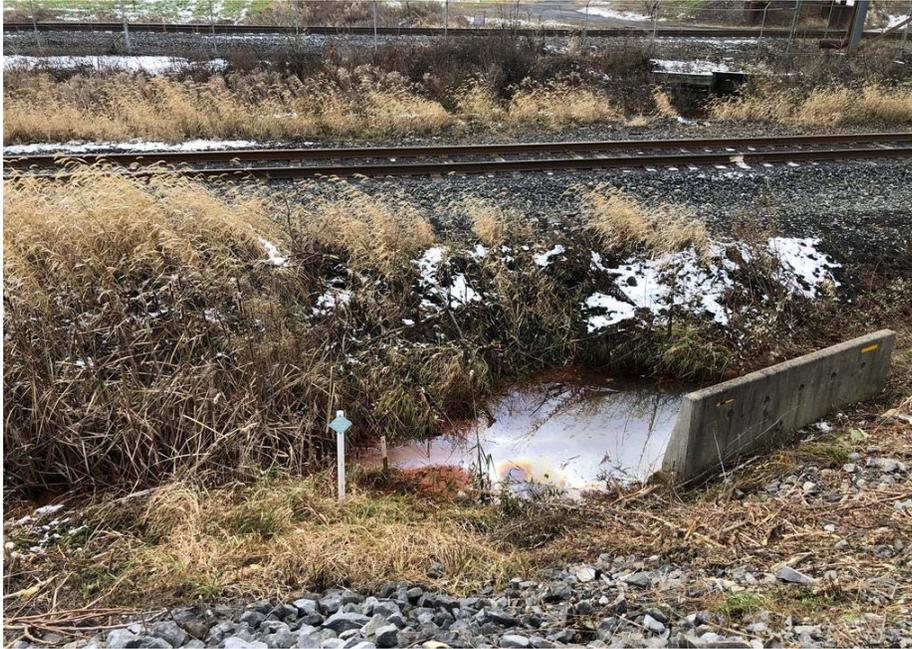
Picture 17 - Very slowly flowing water between the south embankment and the railroad tracks.

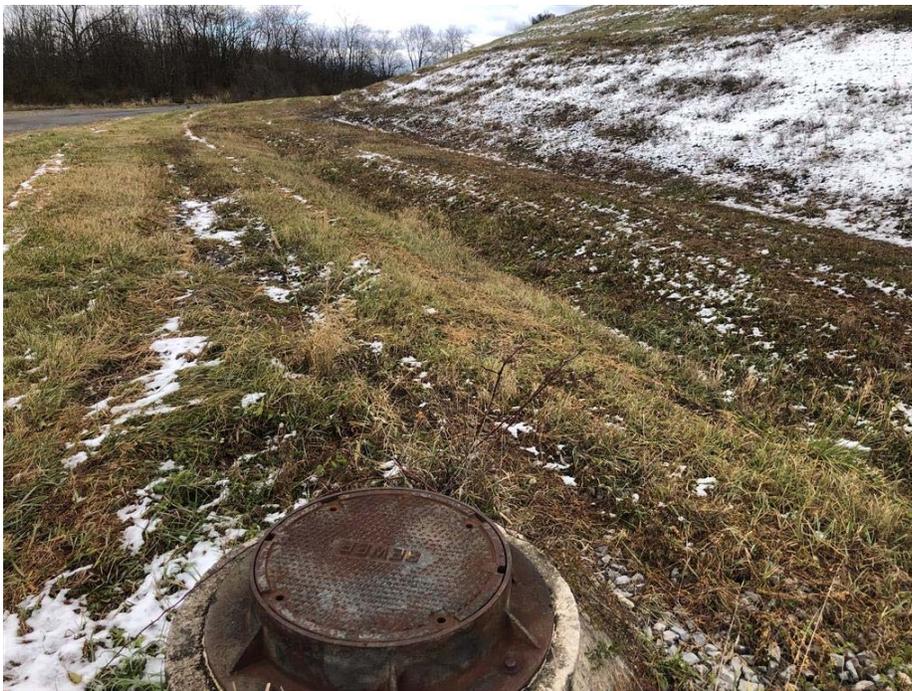
Picture 18 -. Manhole for dewatering well pump #4.

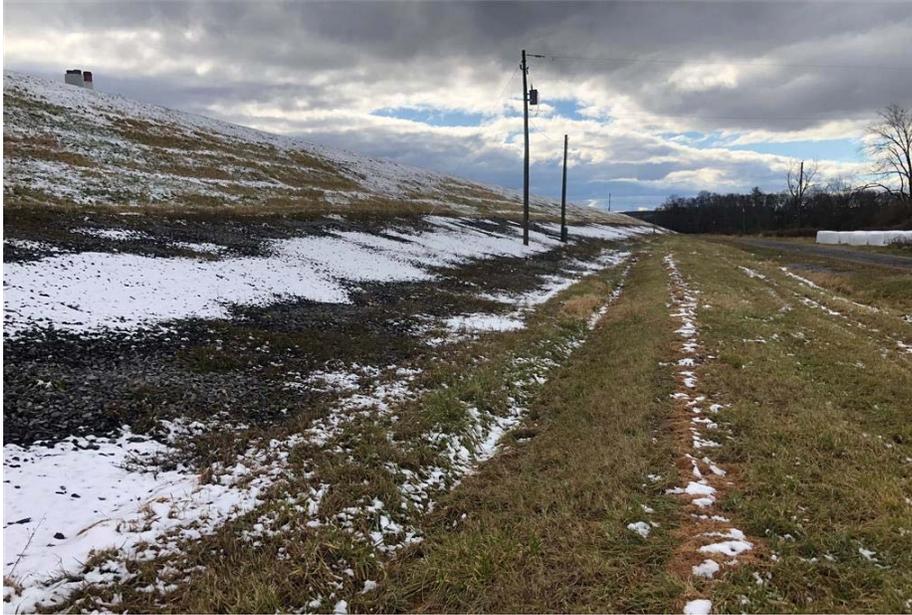
Picture 19 - Toe of slope on the north side. Note the seepage collection trench is in this area and the trench was dry.

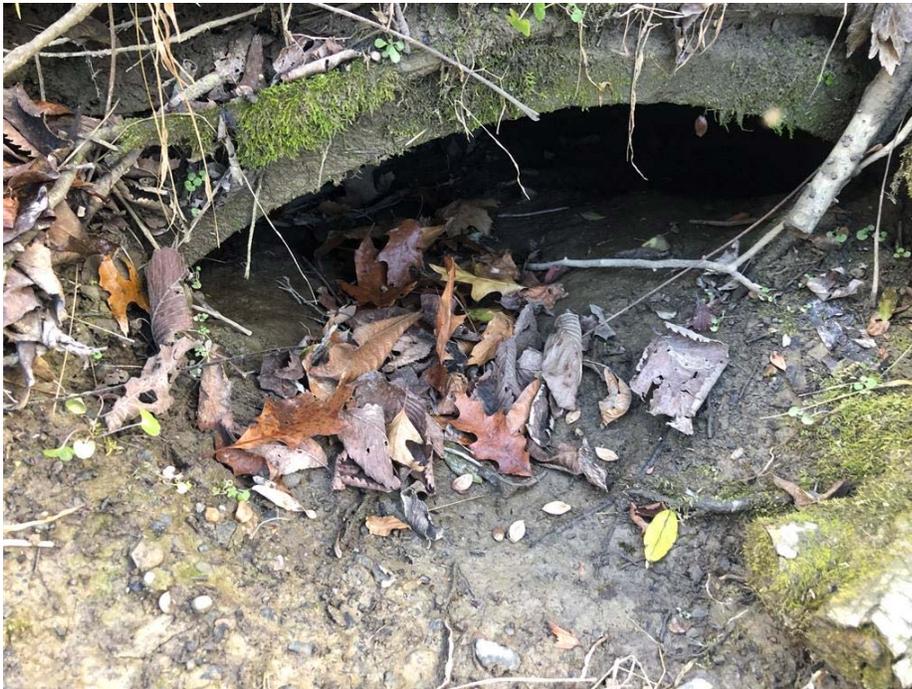
Picture 20 – Concrete filled abandoned pipe.

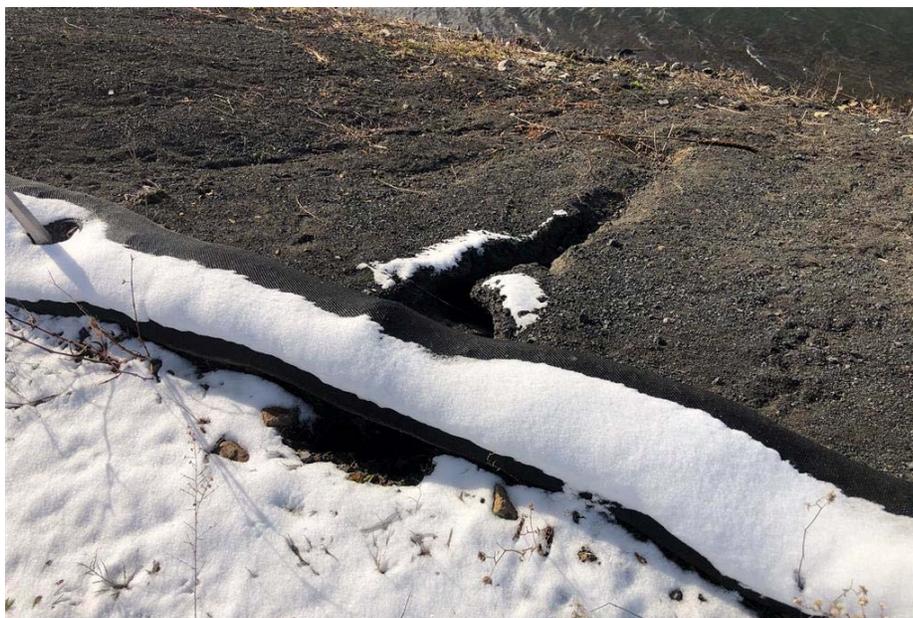
The splitter dike between Sub-basins B and C was in good condition with the exception of 3 shallow erosion scars on the Sub-basin C side below the remaining silt sock from the 2020 work. The silt socks can be removed now that the site is stabilized from the prior work which included lowering the elevation of the dike in a certain area per the Periodic Inflow Design Flood Control System Plan. The dike is broad, so that a shallow failure of the steep downstream slope will not affect the stability of the dike, and, in any event, Sub-basin C should be able to contain any inflow resulting from a failure. It is possible that a slope failure could damage the discharge piping; therefore, continued remote monitoring of the Sub-basin B water level for abnormal increases or decreases is important. The upstream end of the 24-inch CMP inlet to the discharge structure in the splitter dike between Sub-basins B and C was replaced in-kind in 2014. This is a 20' long stub pipe that extends into the basin and a trashrack was installed surrounding the intake pipe in 2015. During the inspection, the water surface elevation was slightly above the invert of the intake structure with little flow entering the discharge structure. The trash rack was clear of debris. The deck of the intake structure had been previously jacked up by over-extension of the gate stem, but was restored in 2015.

Picture 21 - Erosion scar in the splitter dike between cell B and C.

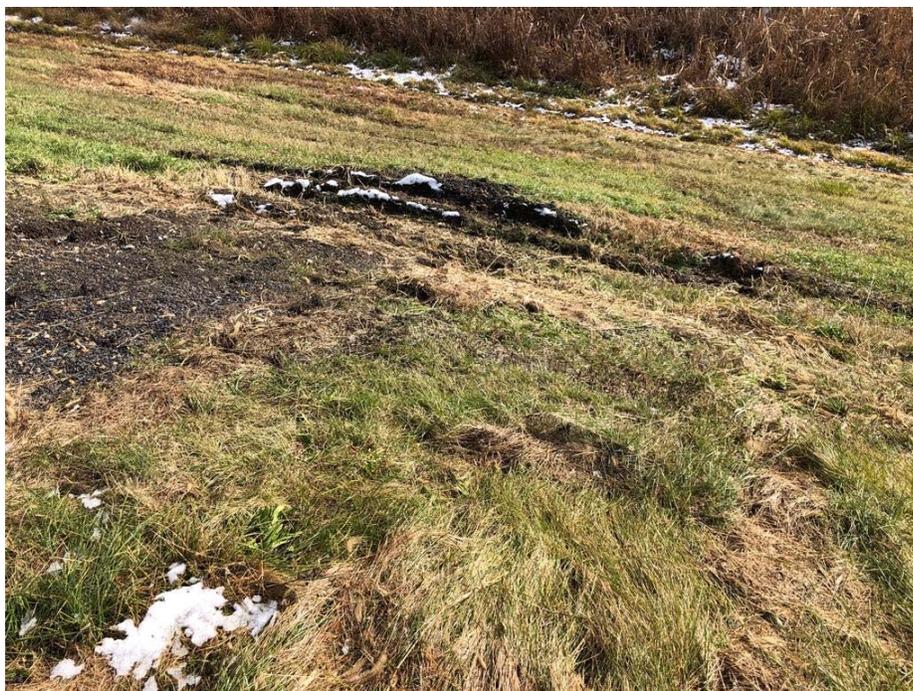
The south embankment was in generally good condition. Ruts from the mowing equipment was observed in a small area. The toe had areas of standing water and a wetland area adjacent to the toe extended from the southwest corner of the basin to near the east end of the south embankment.

Picture 22 – Rutting on embankment from mowing equipment.
